**LITTLE LAKE DAM
JEFFERSON COUNTY, MISSOURI
MO. 30456**

**PHASE I INSPECTION REPORT
NATIONAL DAM SAFETY PROGRAM**

SUBJECT: Little Lake Dam (Mo. 30456) Phase I Inspection Report

Name of Dam: Little Lake Dam,
Missouri Inventory No. 30456
State Located: Missouri
County Located: Jefferson
Stream: Unnamed tributary of Joachim Creek
Date of Inspection: May 8, 1981

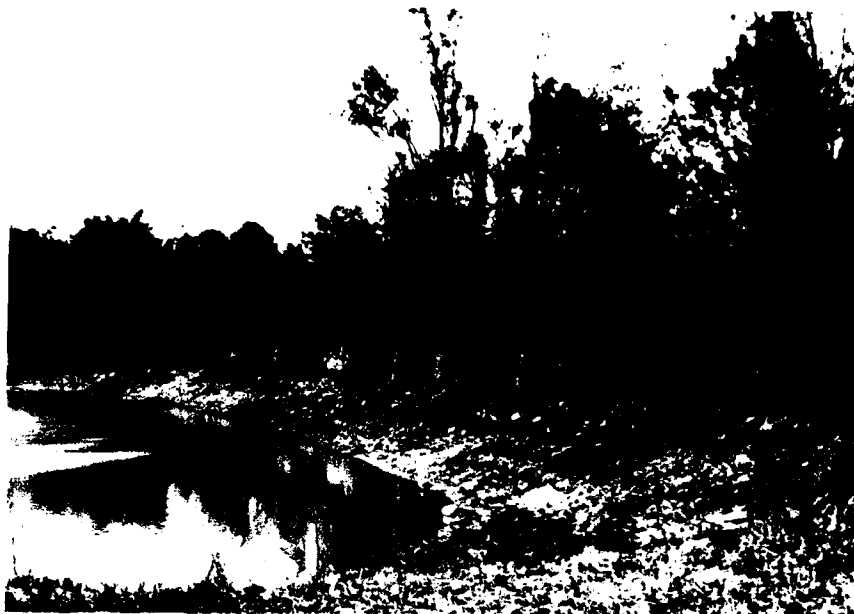
The entire embankment, except for the upstream slope below the normal water surface, is covered by a dense unmaintained vegetative growth ranging from tall grass to large trees (see Photos 1 and 2). A comprehensive inspection of the dam was hampered due to the vegetative cover; however, no bulges, depressions or cracks indicative of an instability of the embankment or foundation were apparent on the dam.

Photo 1 - View of the upstream slope from the right abutment.

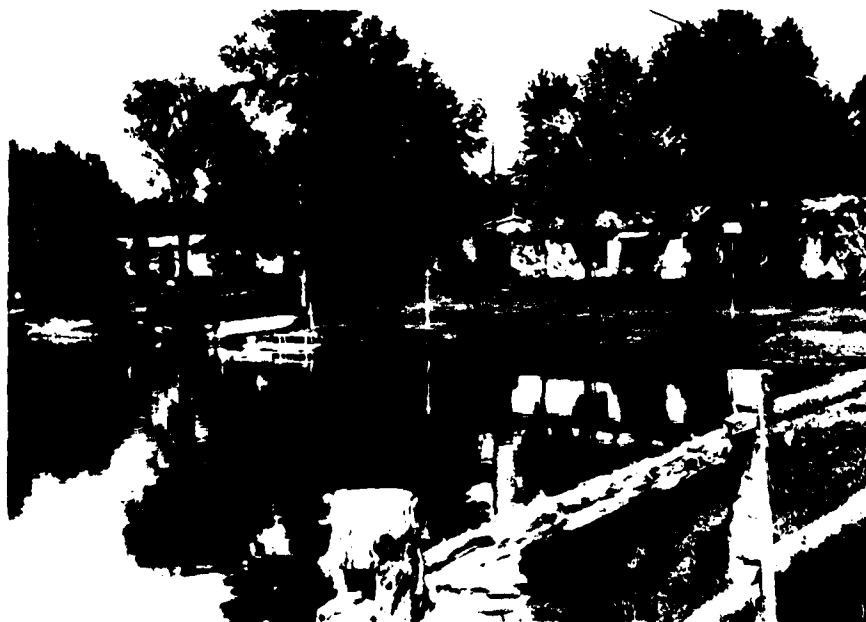
The failure of the dam could cause extensive damage to the property downstream of the dam and possible loss of life. The estimated damage zone extends less than one mile downstream of the dam. Located within the damage zone are one downstream reservoir (Sunrise Lake, Mo. 31190) and at least four dwellings located at the upper end of Sunrise Lake.

Photo 10 - View of dwellings in the downstream hazard zone at the upper end of Sunrise Lake.
